**Flood Control Project Maintenance
Levee Inspections**
LMA District Cover Sheet
Spring 2010 Levee Inspection Results

American River Flood Control District

Spring 2010 Levee Inspection Results

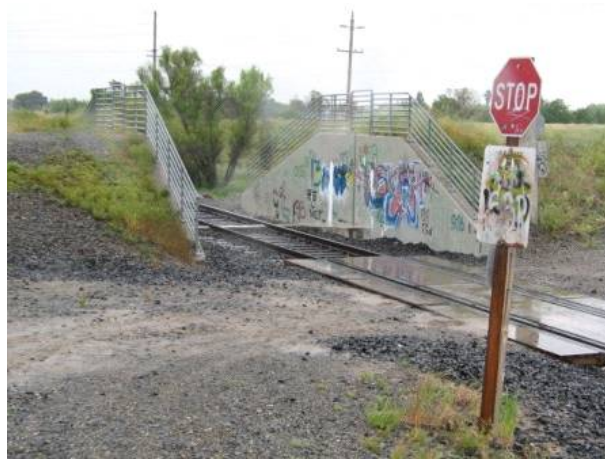
jpaasch_s_20100426_317.jpg

Stop log structure at start of unit.

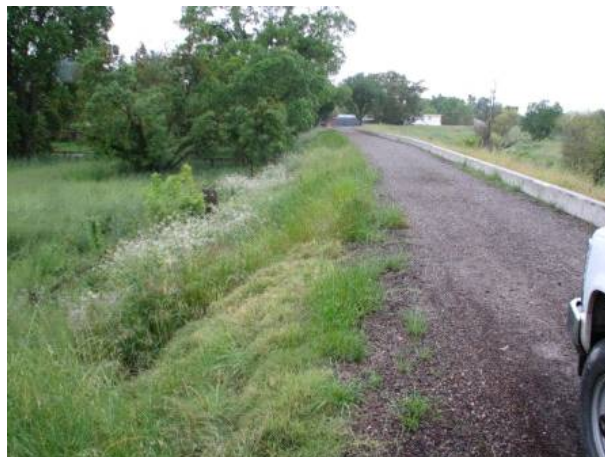
jpaasch_s_20100426_324.jpg

Annual grasses on levee slope.

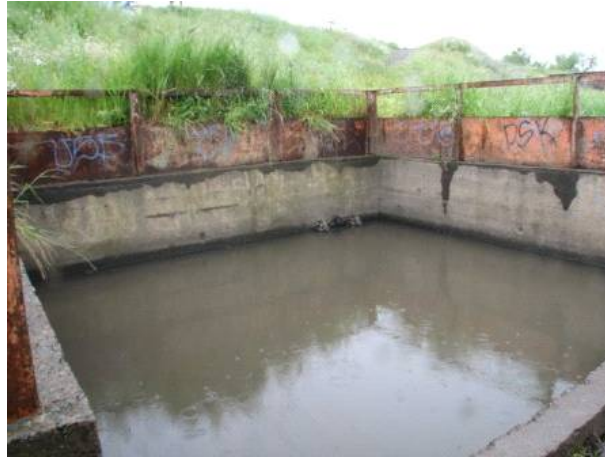
jpaasch_s_20100426_318.jpg

One of several drainage outlets to Arcade Creek at this location.

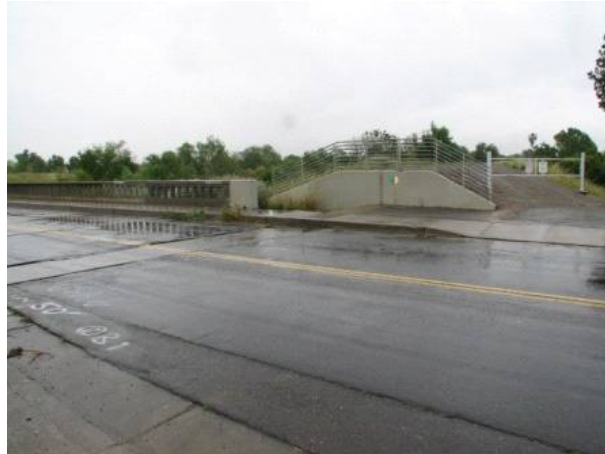
jpaasch_s_20100426_319.jpg

Stoplog structure at Norwood Ave. bridge crossing.

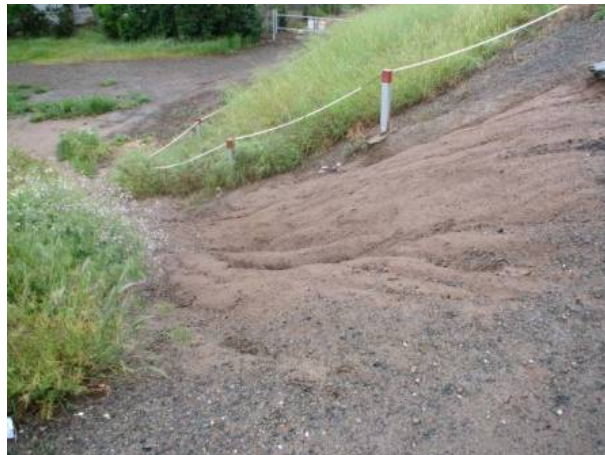
jpaasch_s_20100426_320.jpg

Slope erosion due in part to foot traffic needs to be monitored. Repair will be needed if condition worsens.

| Waterway | | | | | | Bank | Unit Miles | Inspection Start/End | Inspector | |
|---|---|---|---|---|---|---|--|---|---|---|
| 13 | 0.66 | 0.66 | Earthen Levee | Slope Stability | LS | W | Repair the levee slope damaged by vehicle traffic and prevent access where possible. | 38.623675 ° -121.457146 ° | 38.623675 ° -121.457146 ° | 59 Y |

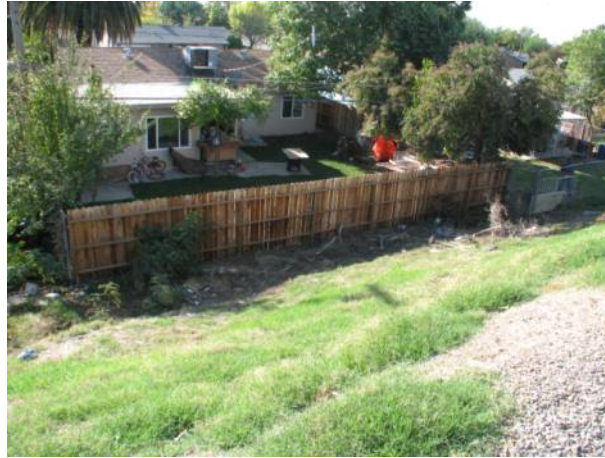
| jpaasch_s_20100330_241.jpg | |

| Fall 2009 photo: Wooden fence within 10-ft of levee toe obstructs visibility. | |

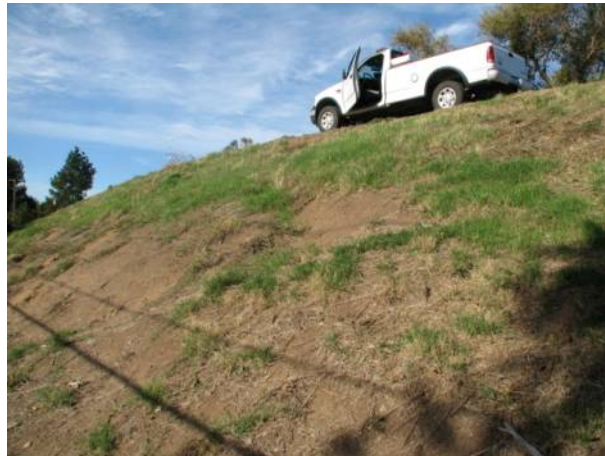
| jpaasch_s_20100330_240.jpg | |

| Photo of levee slope damage caused by foot traffic. | |

| Waterway | | | | | | Bank | Unit Miles | Inspection Start/End | Inspector | |
|---|---|---|---|---|---|---|--|---|---|---|
| 16 | 0.81 | 0.81 | Earthen Levee | Slope Stability | LS | M | Repair the levee slope damaged by foot traffic and prevent access where possible. Inspector Comments: Repair scheduled for June | 38.624305 ° -121.454506 ° | 38.624305 ° -121.454506 ° | 42 Y |

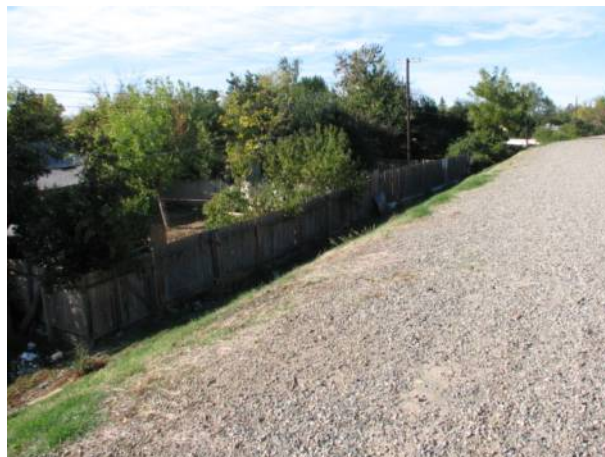
| jpaasch_s_20100330_225.jpg | |

| Photo of solid fences built against the levee slope. | |

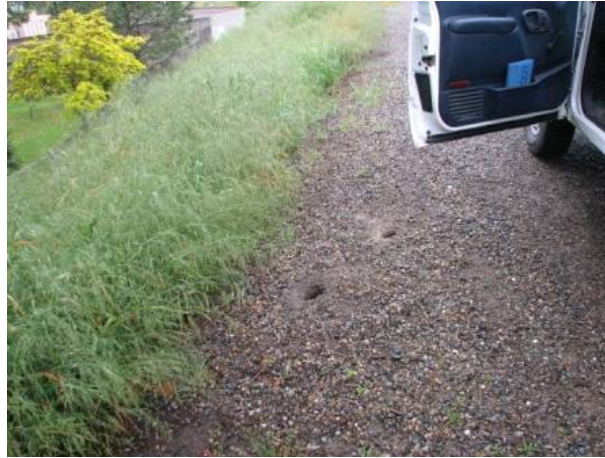
jpaasch_s_20100426_321.jpg

Rodent burrows on levee crown.

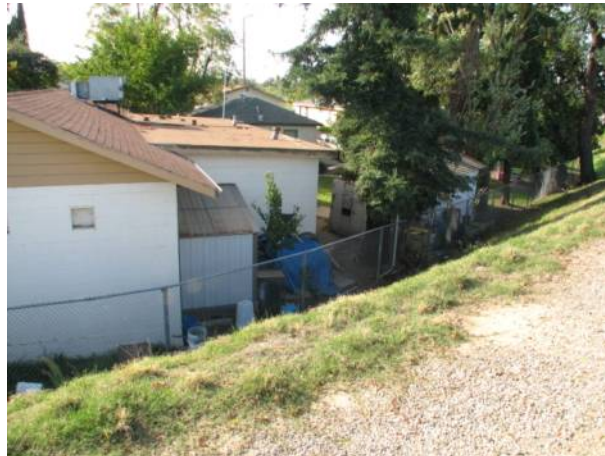
jpaasch_s_20100330_224.jpg

Fall 2009 photo: Buildings and fence near levee toe.

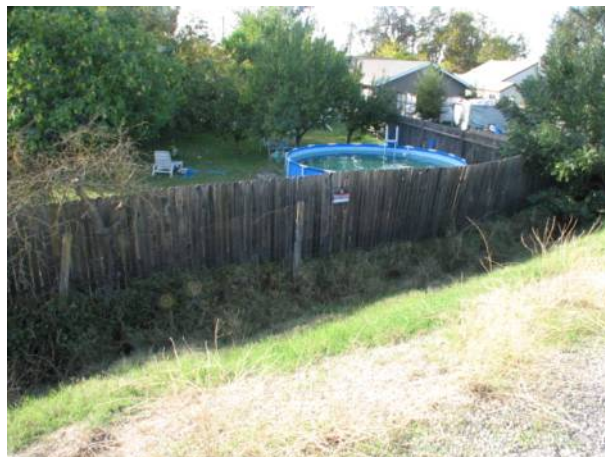
jpaasch_s_20100330_223.jpg

Fall 2009 photo: Wooden and wire fence are within 10-ft of levee toe.

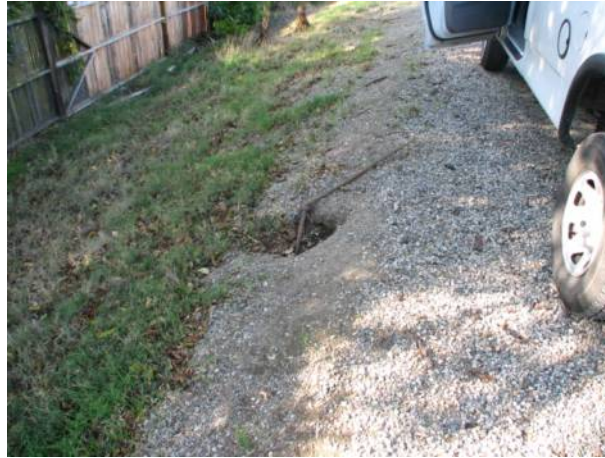
jpaasch_s_20100330_236.jpg

Fall 2009 photo of hole on landside hinge point.

| LMR No | Levee Mile | | Category | Item | Location | Rating | Action/Comment | GPS Latitude/Longitude | | Issue No. Photo |
|---|---|---|---|---|---|---|---|---|---|---|
| 33 | 1.43 | 1.43 | Earthen Levee | Slope Stability | LS | M | Repair slope instability. Inspector Comments: 12" DIA hole on hinge point | 38.626419 ° -121.443842 ° | 38.626419 ° -121.443842 ° | 37 Y |

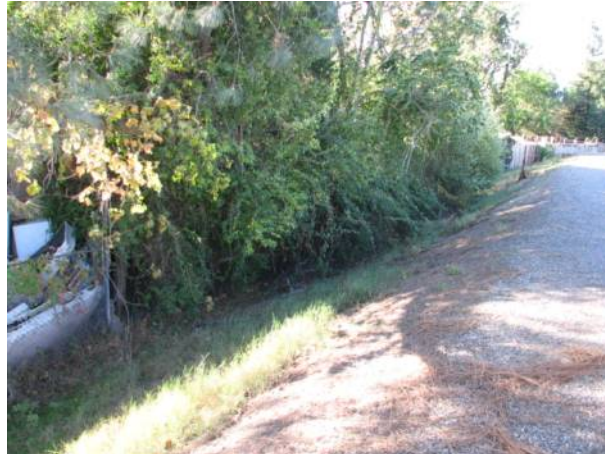
jpaasch_s_20100330_221.jpg

Fall 2009 photo: Brush completely blocks visibility and access to the levee slope and toe.

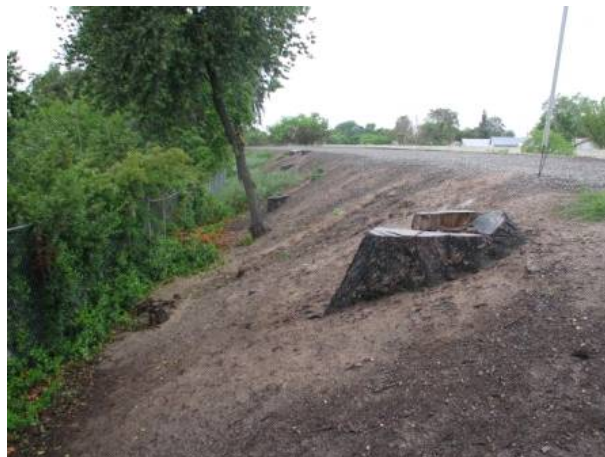
jpaasch_s_20100426_322.jpg

Several large stumps on levee slope.

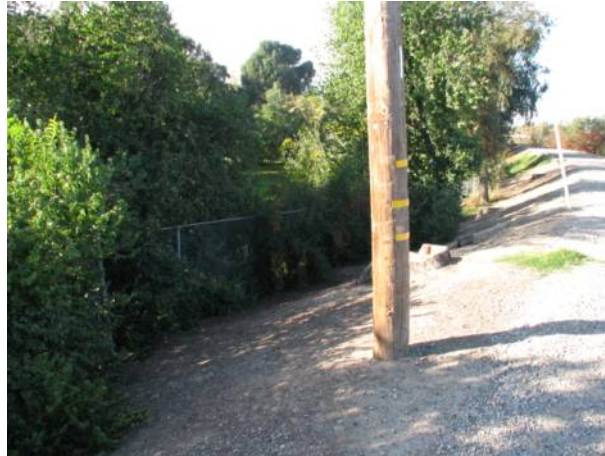
| jpaasch_s_20100330_234.jpg | |

| Fall 2009 photo:Vegetation obstructing visibility near levee slope. | |

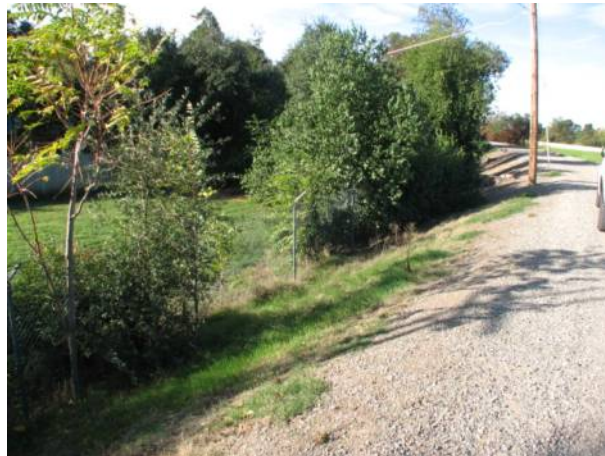
| jpaasch_s_20100330_220.jpg | |

| Fall 2009 photo: Photinias and other plants planted near levee toe. | |

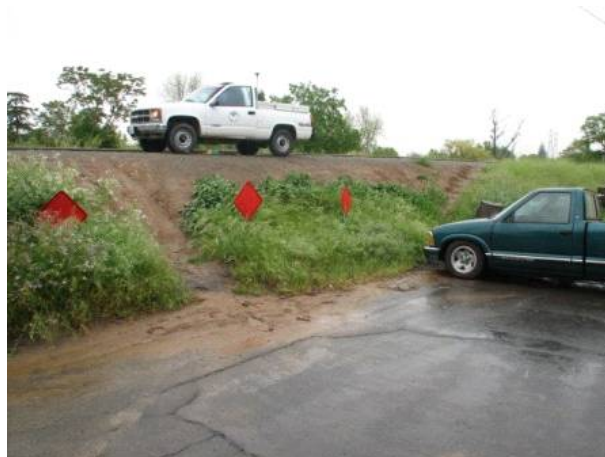
| jpaasch_s_20100426_328.jpg | |

| Slope stability due to foot traffic needs to be monitored. | |

| LMR No | Levee Mile | | Category | Item | Location | Rating | Action/Comment | GPS Latitude/Longitude | | Issue No. Photo |
|---|---|---|---|---|---|---|---|---|---|---|
| 40 | 1.58 | 1.58 | Earthen Levee | Slope Stability | LS | W | Repair the levee slope damaged by foot traffic and prevent access where possible. | 38.627251 ° -121.441460 ° | 38.627251 ° -121.441460 ° | 54 Y |

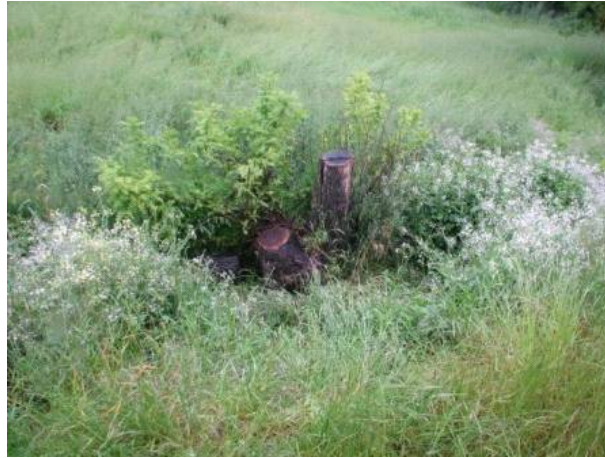
jpaasch_s_20100426_326.jpg

Tree stump with some new growth.

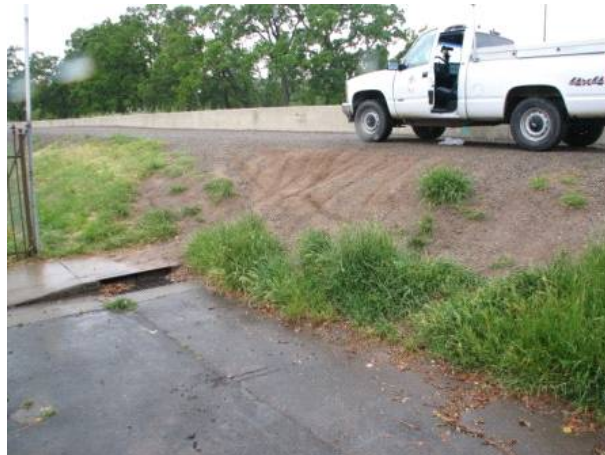
jpaasch_s_20100426_325.jpg

Slope stability issue due to foot traffic.

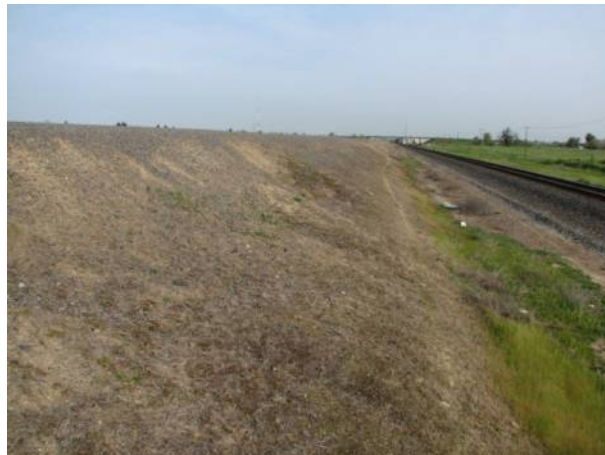
jpaasch_s_20100324_085.jpg

Fall 2009 photo of riveting on landside slope.

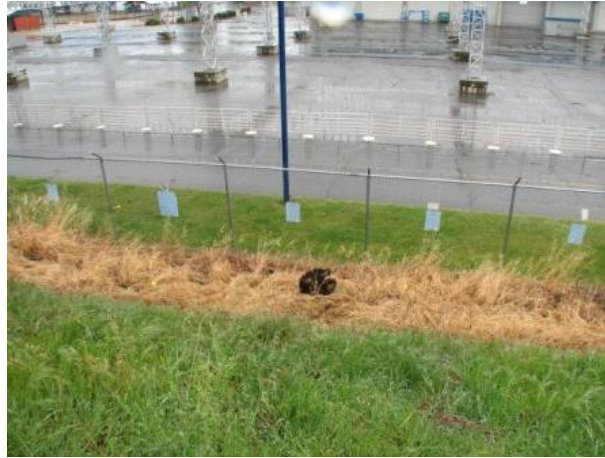
jpaasch_s_20100426_327.jpg

Tree stump on levee slope greater than 2" Dia.

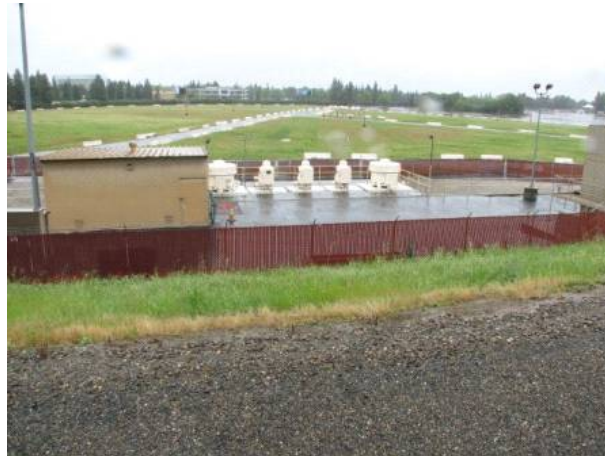
jpaasch_s_20100426_333.jpg

Drainage pump plant at Cal Expo.

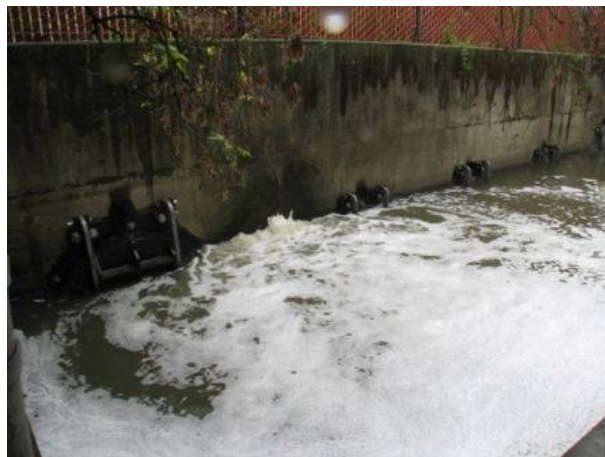
jpaasch_s_20100426_334.jpg

Drainage discharge to American River.

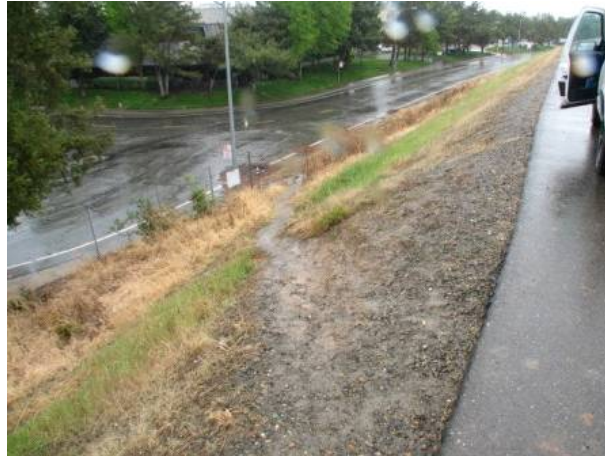
| jpaasch_s_20100426_335.jpg | |

| Slope needs to be monitored due to heavy foot traffic. | |

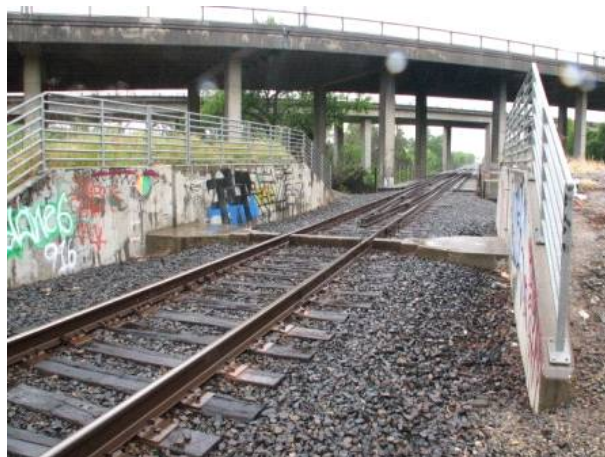
| jpaasch_s_20100426_331.jpg | |

| Stoplog closure structure at RR near Del Paso Blvd. | |

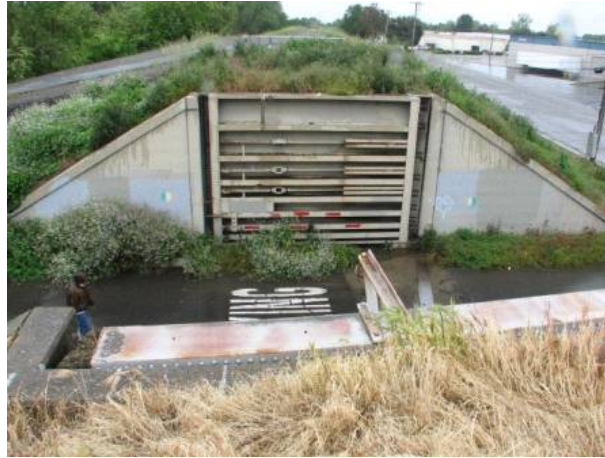
jpaasch_s_20100426_330.jpg

Closure structure crossing Del Paso Blvd.

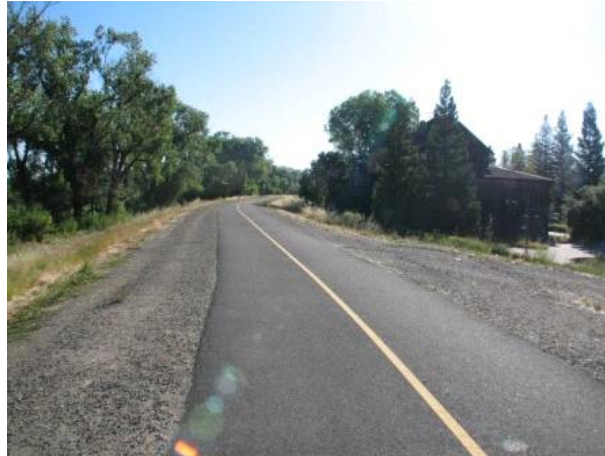
| jpaasch_s_20100514_400.jpg | |

| Annual grasses on levee slopes. Photo taken east of I-5. | |

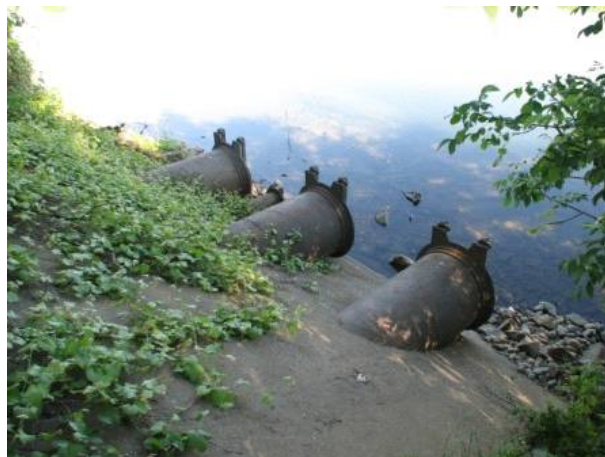
| jpaasch_s_20100514_402.jpg | |

| Outlet of storm drain to American River. | |

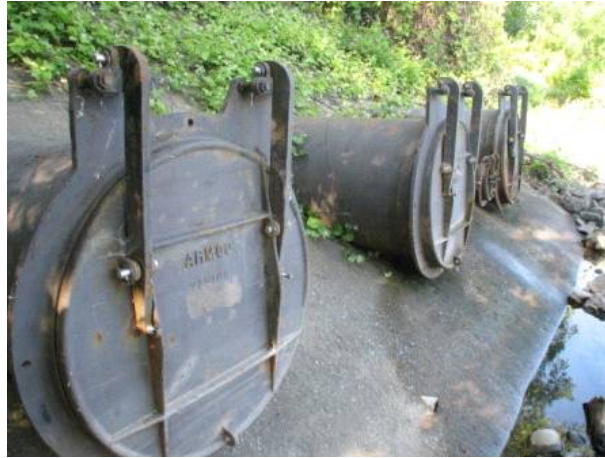
jpaasch_s_20100514_403.jpg

Flap gates functioning properly.

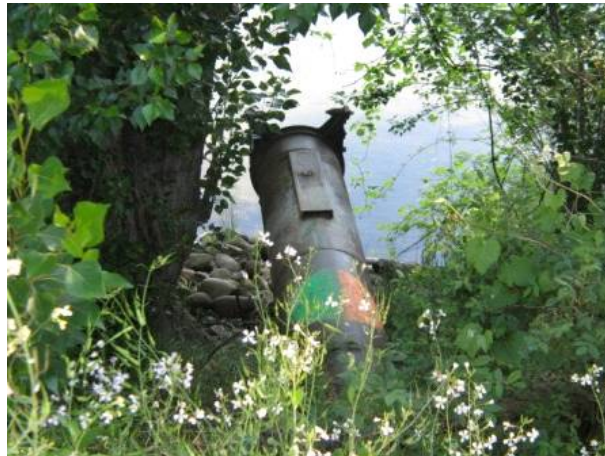
jpaasch_s_20100514_404.jpg

Discharge pipe from printing into American River.

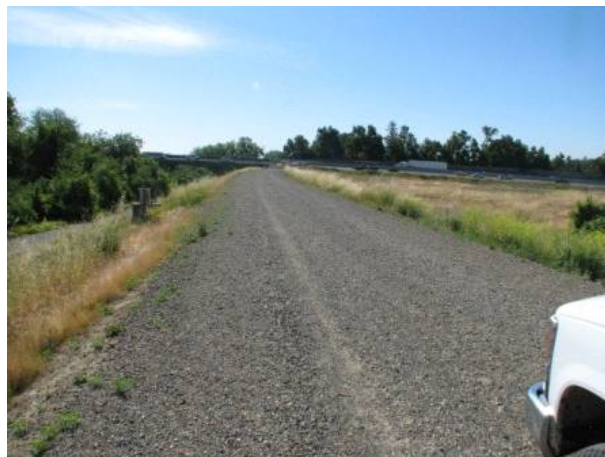
jpaasch_s_20100520_435.jpg

Annual grass on levee slopes exceeds 12 inches.

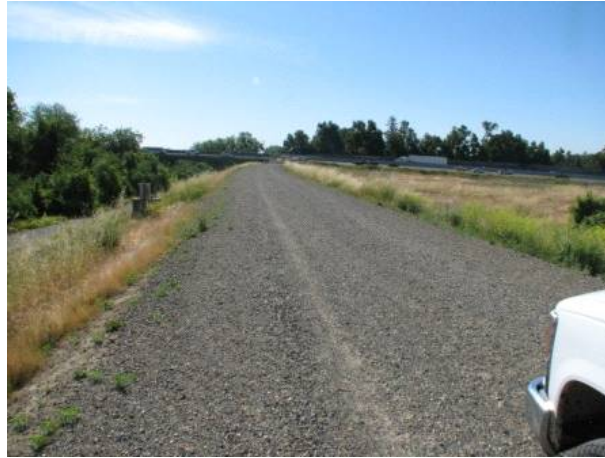
jpaasch_s_20100514_405.jpg

Annual grasses on levee slope.

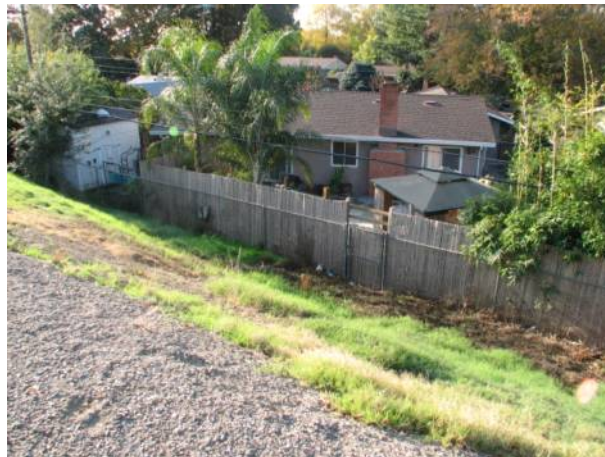
jpaasch_s_20100330_178.jpg

Fall 2009 photo: Fence and landscaping within 10-ft of levee toe obstructs access and visibility.

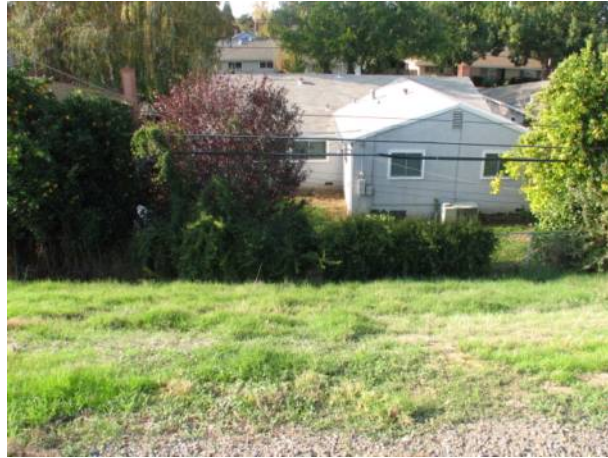
jpaasch_s_20100330_206.jpg

Fall 2009 photo: Landscaping within 10-ft of levee toe obstructs access and visibility.

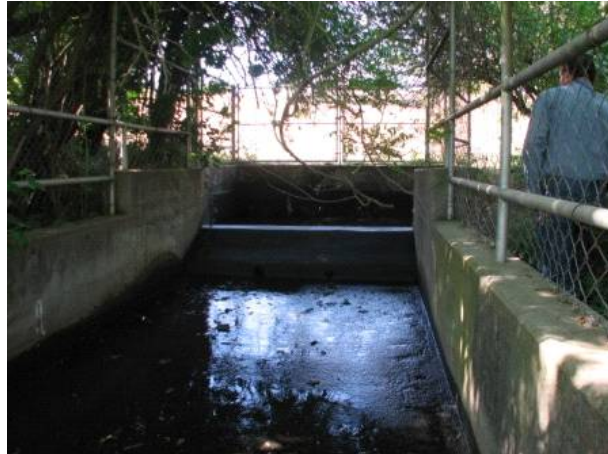
jpaasch_s_20100514_406.jpg

Storm water discharge to American River.

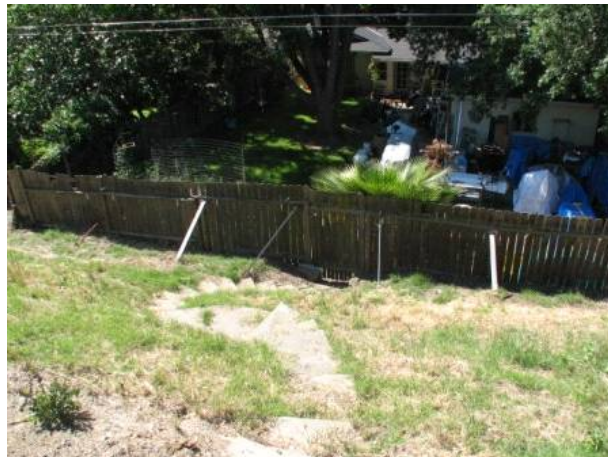
jpaasch_s_20100514_407.jpg

Wooden fence and braces obstruct access and visibility.

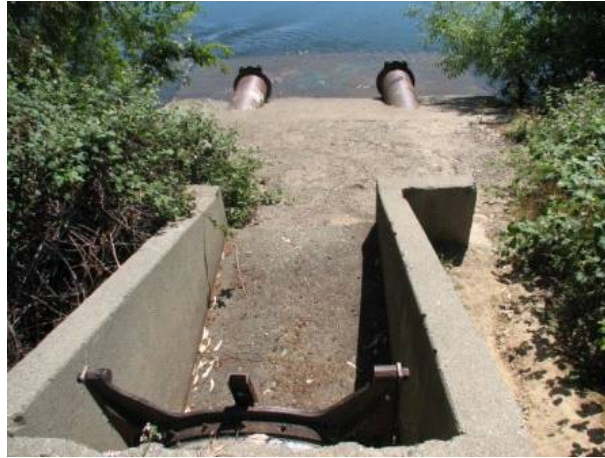
jpaasch_s_20100514_408.jpg

| LMR No | Levee Mile | | Category | Item | Location | Rating | Action/Comment | GPS Latitude/Longitude | | Issue No. Photo |
|---|---|---|---|---|---|---|--|---|---|---|
| 195 | 9.49 | 9.49 | Earthen Levee | Encroachments | WS | W | Pipe Inspector Comments: Flap gates in good condition. | 38.566700 ° -121.372961 ° | 38.566700 ° -121.372961 ° | 175 Y |

Drainage discharge to American River.

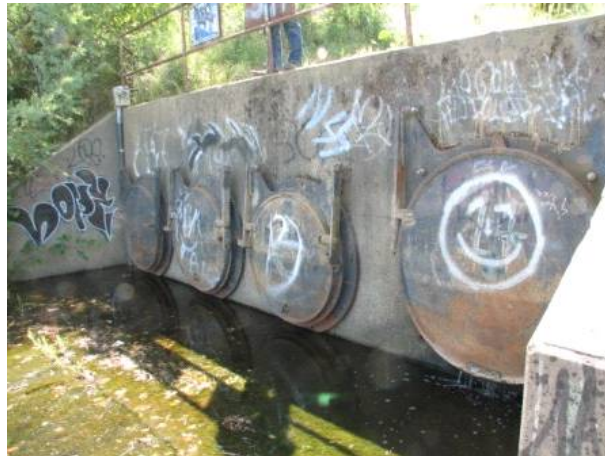
jpaasch_s_20100505_364.jpg

Drainage outfall to American River.

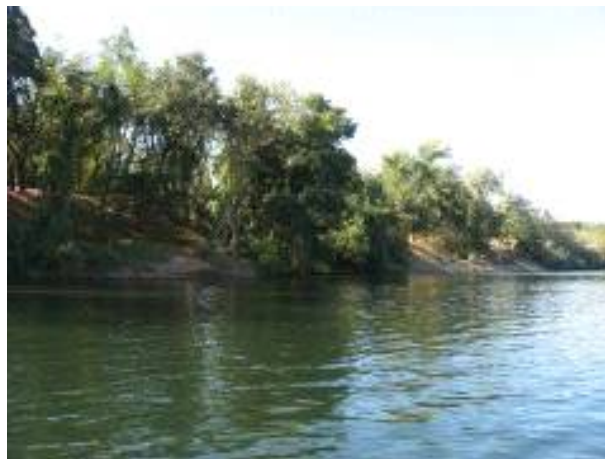
USACE2009_AMR_10-0_L_2009_09_22-D7P18_small.JPG

| LMR No | Levee Mile | | Category | Item | Location | Rating | Action/Comment | GPS Latitude/Longitude | | Issue No. Photo |
|---|---|---|---|---|---|---|--|---|---|---|
| 196 | 9.52 | 9.61 | Supplemental | USACE Erosion Survey | WS | M | Inspector Comments: 2009: 10 ft berm, 1.5:1 slope, tree hazards, clays and silts, 8.74 ft/s [2009 SiteID:AMR_10-0_L] | 38.567567 ° -121.370894 ° | 38.567269 ° -121.372572 ° | 260 Y |

2009: 10 ft berm, 1.5:1 slope, tree hazards, clays and silts, 8.74 ft/s [2009 SiteID:AMR_10-0_L]

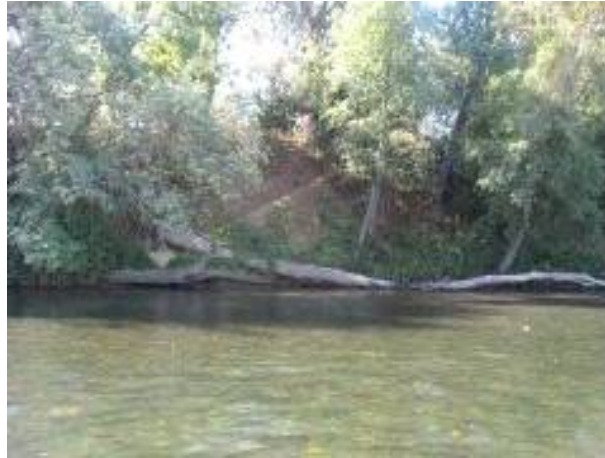
| USACE2009_AMR_10-6_L_2009_09_22-D7P19_small.JPG | |

| LMR No | Levee Mile | | Category | Item | Location | Rating | Action/Comment | GPS Latitude/Longitude | | Issue No. Photo |
|---|---|---|---|---|---|---|---|---|---|---|
| 221 | 10.19 | 10.21 | Supplemental | USACE Erosion Survey | WS | M | Inspector Comments: 2009: 15 ft berm, vertical slope, tree hazards and holes, clays and silts, 3.94 ft/s [2009 SiteID:AMR_10-6_L] | 38.569833 ° -121.360422 ° | 38.569708 ° -121.360867 ° | 261 Y |

| 2009: 15 ft berm, vertical slope, tree hazards and holes, clays and silts, 3.94 ft/s [2009 SiteID:AMR_10-6_L] | |

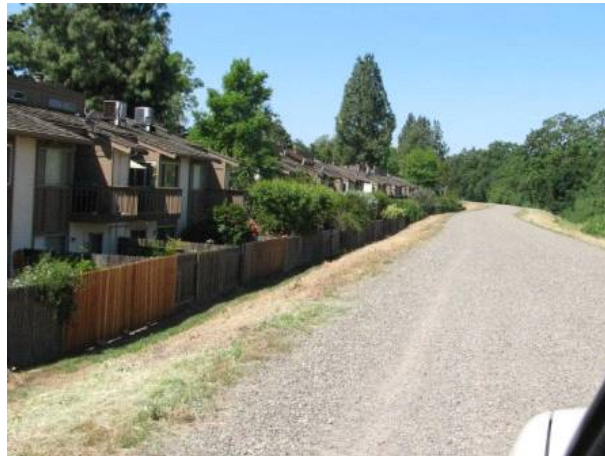
| jpaasch_s_20100505_363.jpg | |

| Wooden fence behind apartments within 10' of levee toe. | |

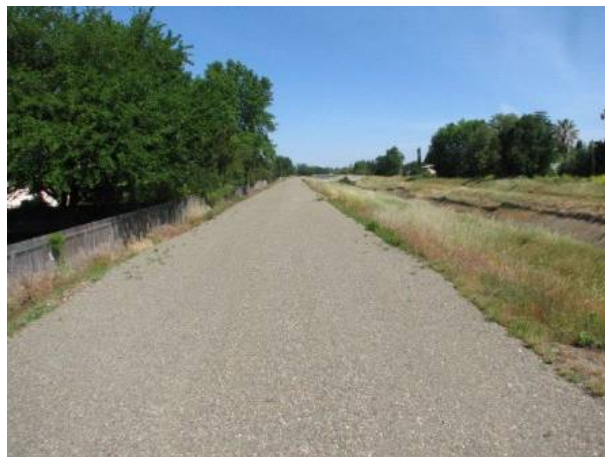
| jpaasch_s_20100505_361.jpg | |

| Annual grasses on slope at Mahew Drain. | |

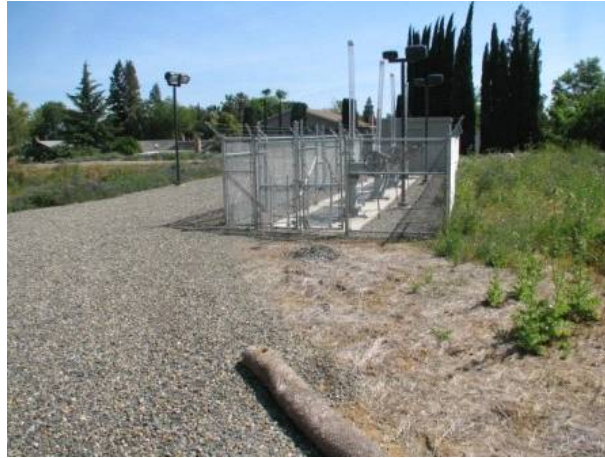
jpaasch_s_20100505_362.jpg

Mahew drain closure structure.

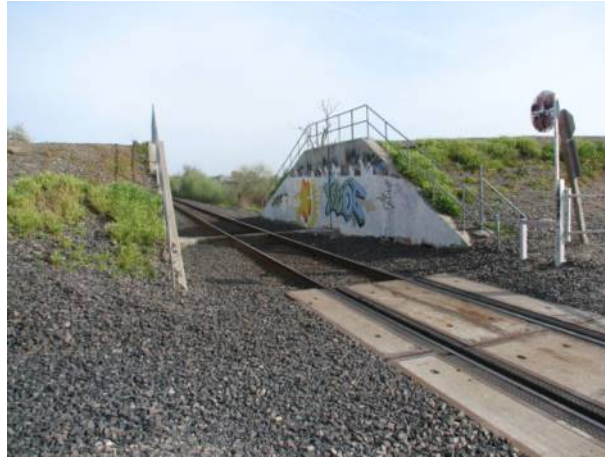
jpaasch_s_20100324_084.jpg

Stoplog structure at LM 0.00 on unit 6.

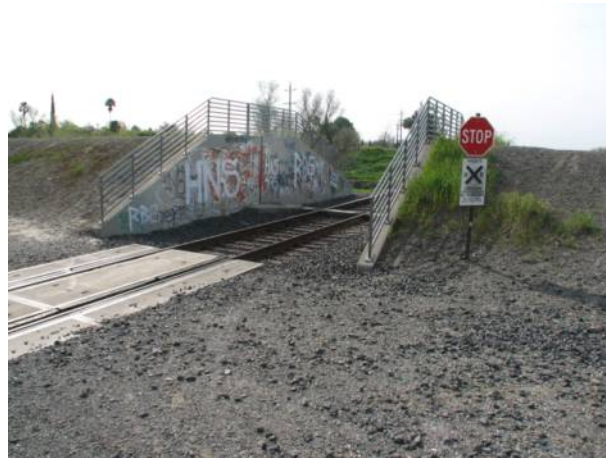
jpaasch_s_20100324_086.jpg

Stoplog closure structure at Unit 7 connection with Unit 2.

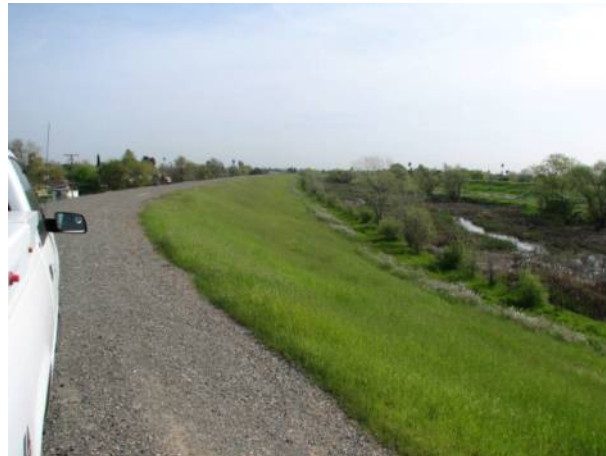
jpaasch_s_20100324_087.jpg

Annual grasses on levee slopes.

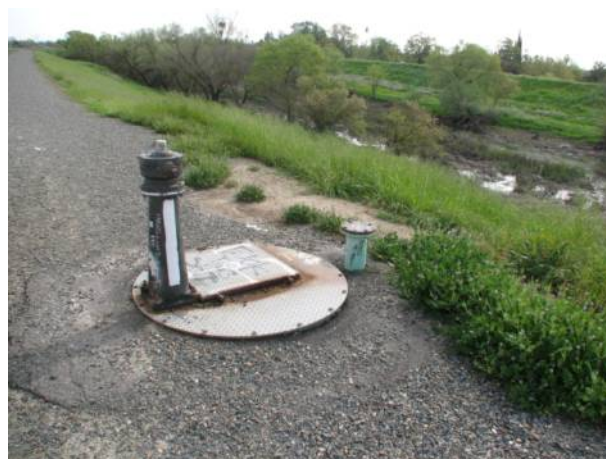
jpaasch_s_20100324_088.jpg

Closure device for SS beneath channel.

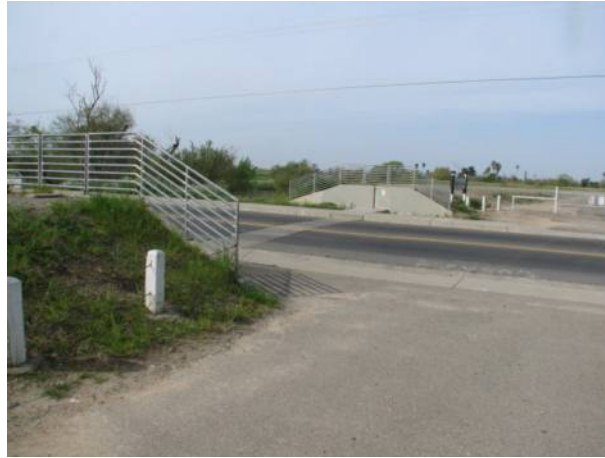
jpaasch_s_20100324_089.jpg

Stoplog structure at Norwood Ave. crossing.

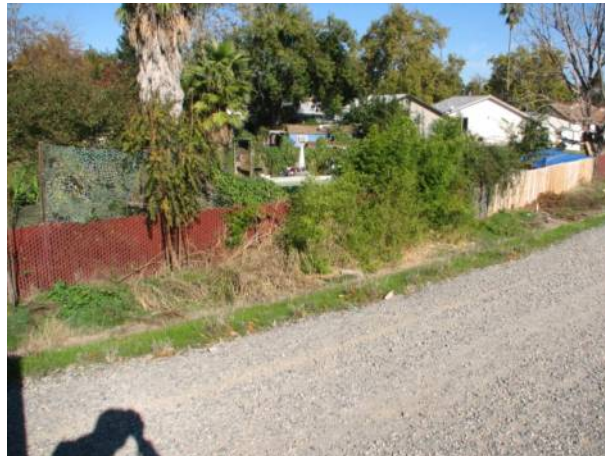
jpaasch_s_20100324_041.jpg

Fall 2009 photo of landscaping adjacent to lower levee patrol road obstructs visibility and access.

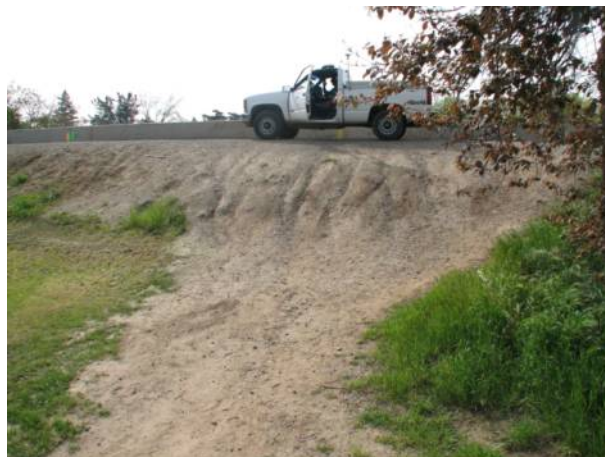
jpaasch_s_20100324_090.jpg

Erosion of levee slope due in part to pedestrian traffic.

| LMR No | Levee Mile | | Category | Item | Location | Rating | Action/Comment | GPS Latitude/Longitude | | Issue No. Photo |
|---|---|---|---|---|---|---|---|---|---|---|
| 17 | 1.58 | 1.58 | Earthen Levee | Slope Stability | LS | W | Repair the levee slope damaged by foot traffic and prevent access where possible. Inspector Comments: Heavy foot traffic at this location. | 38.627774 ° -121.441604 ° | 38.627774 ° -121.441604 ° | 40 Y |

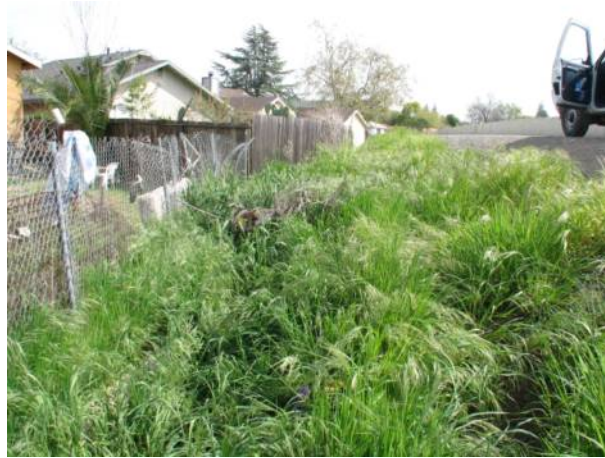
jpaasch_s_20100324_091.jpg

Tree stump at landside toe.

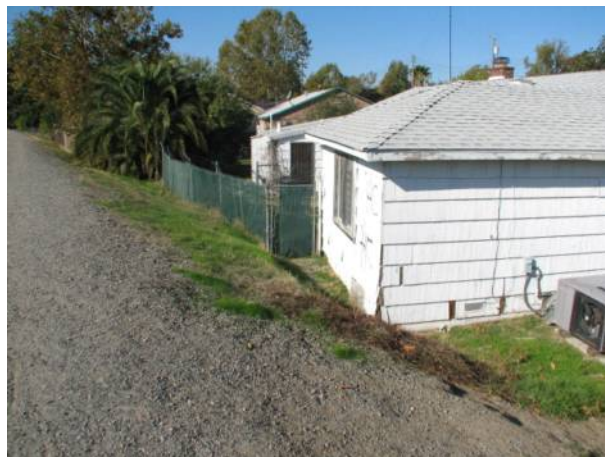
jpaasch_s_20100324_029.jpg

Fall 2009 photo of privacy fence and structure within 10-ft of the levee toe obstructs visibility and access.

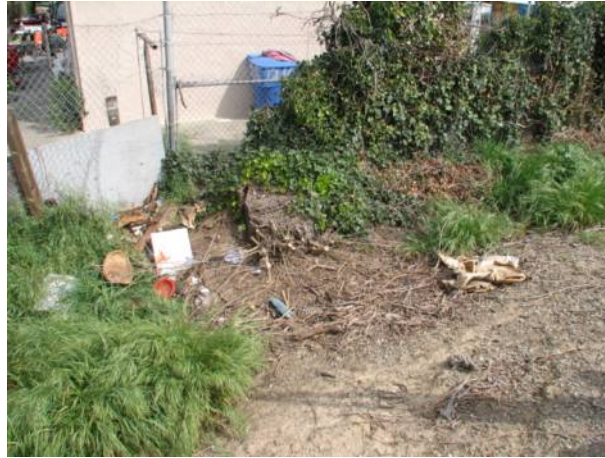
jpaasch_s_20100324_092.jpg

Tree stump at landside toe.

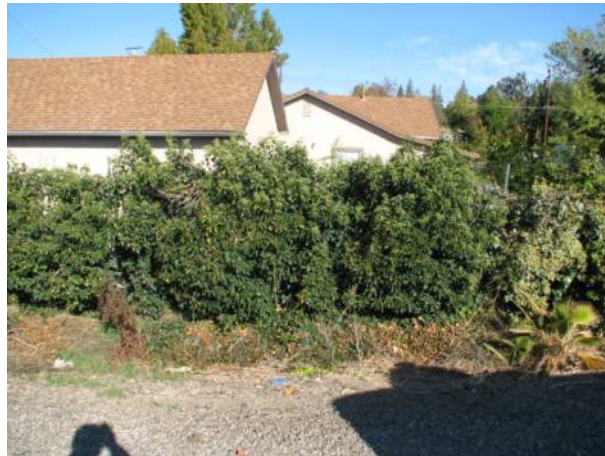
jpaasch_s_20100324_031.jpg

Fall 2009 photo of landscaping within 10-ft of the levee toe obstructs visibility and access.

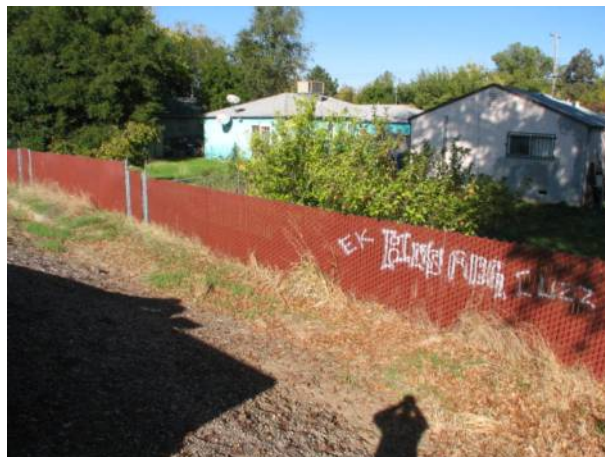
jpaasch_s_20100324_033.jpg

Fall 2009 photo of privacy fence within 10-ft of the levee toe obstructs visibility and access.

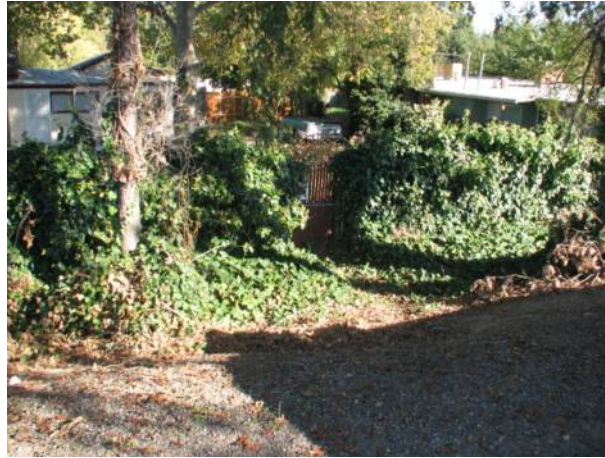
jpaasch_s_20100324_034.jpg

Fall 2009 photo of dense ivy and fence obstruct visibility and access.

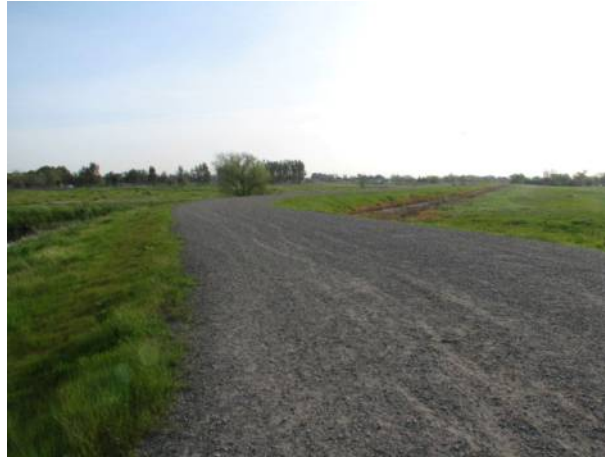
jpaasch_s_20100324_079.jpg

Annual grasses on levee slopes.

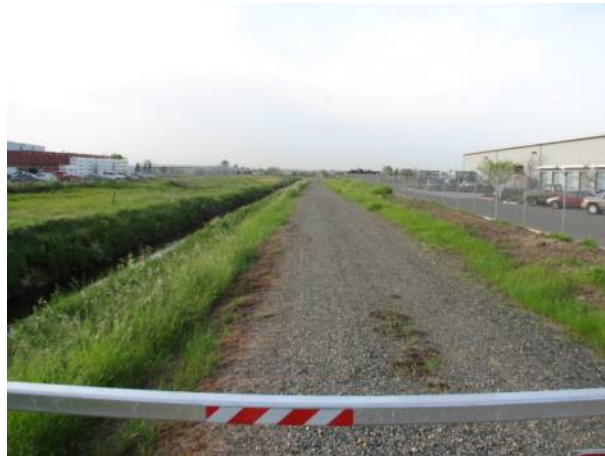
jpaasch_s_20100324_078.jpg

Annual grasses on levee slopes.

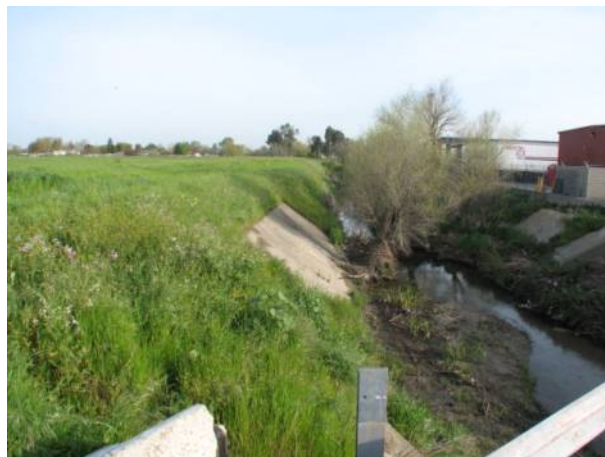
jpaasch_s_20100324_080.jpg

Incized channel at LM 1.05 downstream of Vinci Ave.
